# **CORNWALL ENERGY RECOVERY CENTRE**

## Neighbourhoods Overview and Scrutiny Committee Turbine Damage and Repairs Report

Date of Incident: 22 June 2018

Date of Report: 13 September 2019

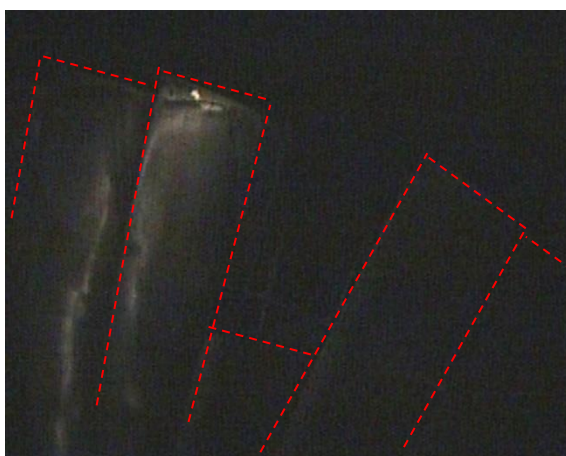
On 28 June 2018, TGM staff arrived on site and started their investigation. On 29 June 2018 an internal inspection within the turbine case using a boroscope identified that one of the blades within the final stage of the turbine appeared to be broken (Figure 1).

*Figure 1: Boroscope photo of broken blade. Blades have been outlined with red dashed lines. Gap where part of the blade is missing can clearly be seen*

Following the identification of the broken blade the CERC was shut down in order for SUEZ O&M to install a blanking plate (a large metal disc inserted at Flange Y in order to provide a physical barrier between the high pressure and temperature steam produced when the plant is operating and the members of staff working on the turbine and within the turbine hall). Once the blanking plate was inserted, the waste treatment lines were restarted to allow waste to continue to be treated. The turbine was then opened and the rotor examined, removed from its casing, packaged and sent to a workshop in Antwerp for repair and root cause investigation (Figure 2).

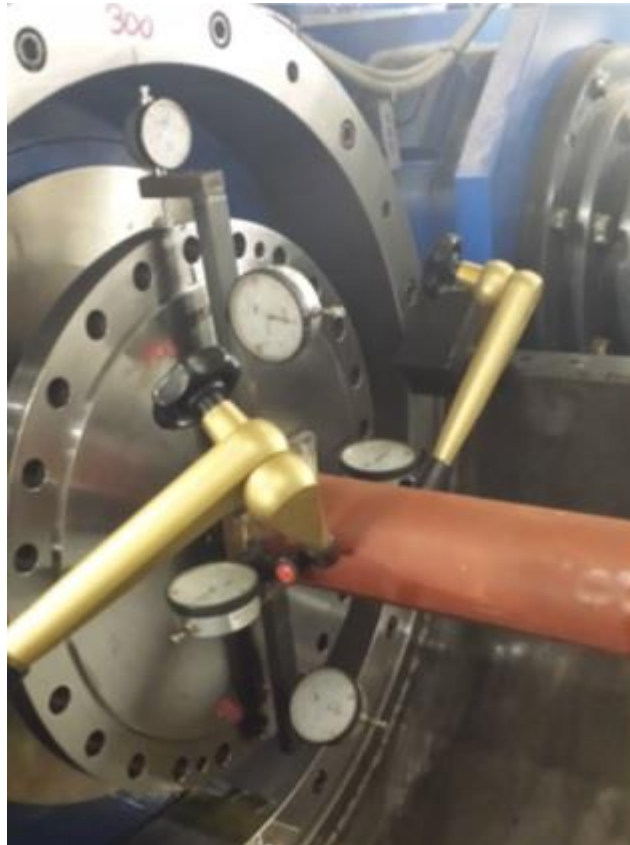
On 27 October 2018 the CERC was shut down in order to conduct the investigation into Flange X. On 02 November 2018 all of the above listed parties witnessed Flange X being opened by Uniper and the turbine was proven to be strain free as the turbine side of the flange did not move.

*Figure 4: Movement monitoring devices attached to the TGM alignment bar confirming no movement of the turbine or gearbox when Flange X was opened.*
